UTAH COUNTY TECHNICAL BULLETIN

April, 2010-2

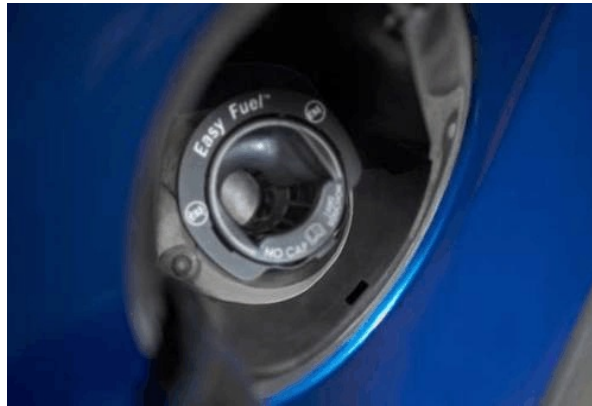
Beginning in 2007 the Ford Motor Company started using a cap-less fuel filler system on select models. They are currently expanding the use of this system across the North American model line. If you haven't seen one of these yet, you will soon. At first glance it looks like the gas cap is missing. Upon closer examination you'll notice the words "Easy Fuel" on the upper part of the filler neck and the words "NO CAP" on the lower portion. There is an optional locking fuel plug available and an available rubber fuel plug for use in dusty conditions. These "fuel plugs" do not need to be present in order to pass the visual inspection.

The actual sealing portion, or fuel cap, of the system is below the flapper portion of the filler neck. This system is an approved fuel vapor sealing system and should be marked "pass" during the gas cap portion of the visual tampering inspection.
